**Aircraft Accident and Incident Investigation  
Office,  
State of Kuwait**

-----  
**Report on the Serious Incident on the Loss of Separation  
between A320 and ATR72-500 at  
Tribhuvan International Airport (VNKT), Kathmandu  
on 24 May 2025**  
-----

## Final Report

**Date and Time of Occurrence:** 24 May 2025 at 0707 Local Time (0122 UTC)

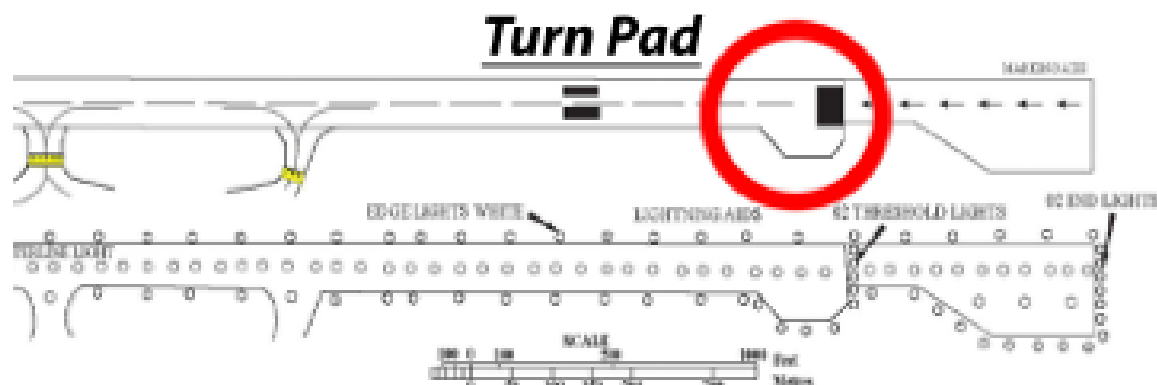
In the case of VNKT, the turn pad was located before the end of the runway to reduce taxiing time. Figure 2 – location of the turn pad

- 2.5 Turn Pad – ICAO Annex 14, Volume I - Aerodrome Design and Operations has the following about turn pad: -

- 2.20 The JZR1540 entered the runway at 07:03:10L. The turn pad near the departure end of RWY 02 was not designed for holding and the presence of any aircraft on the pad or on the single runway would become an obstacle to other aircraft on the approach for landing. It must then be ruled that from the moment the JZR 1540 entered the runway via taxiway E, the runway was occupied by it, and no other aircraft could take-off or land on the runway until the JZR 1540 left the runway or flying away. In this respect, ATC must closely monitor other traffic to provide positive control to maintain separation.

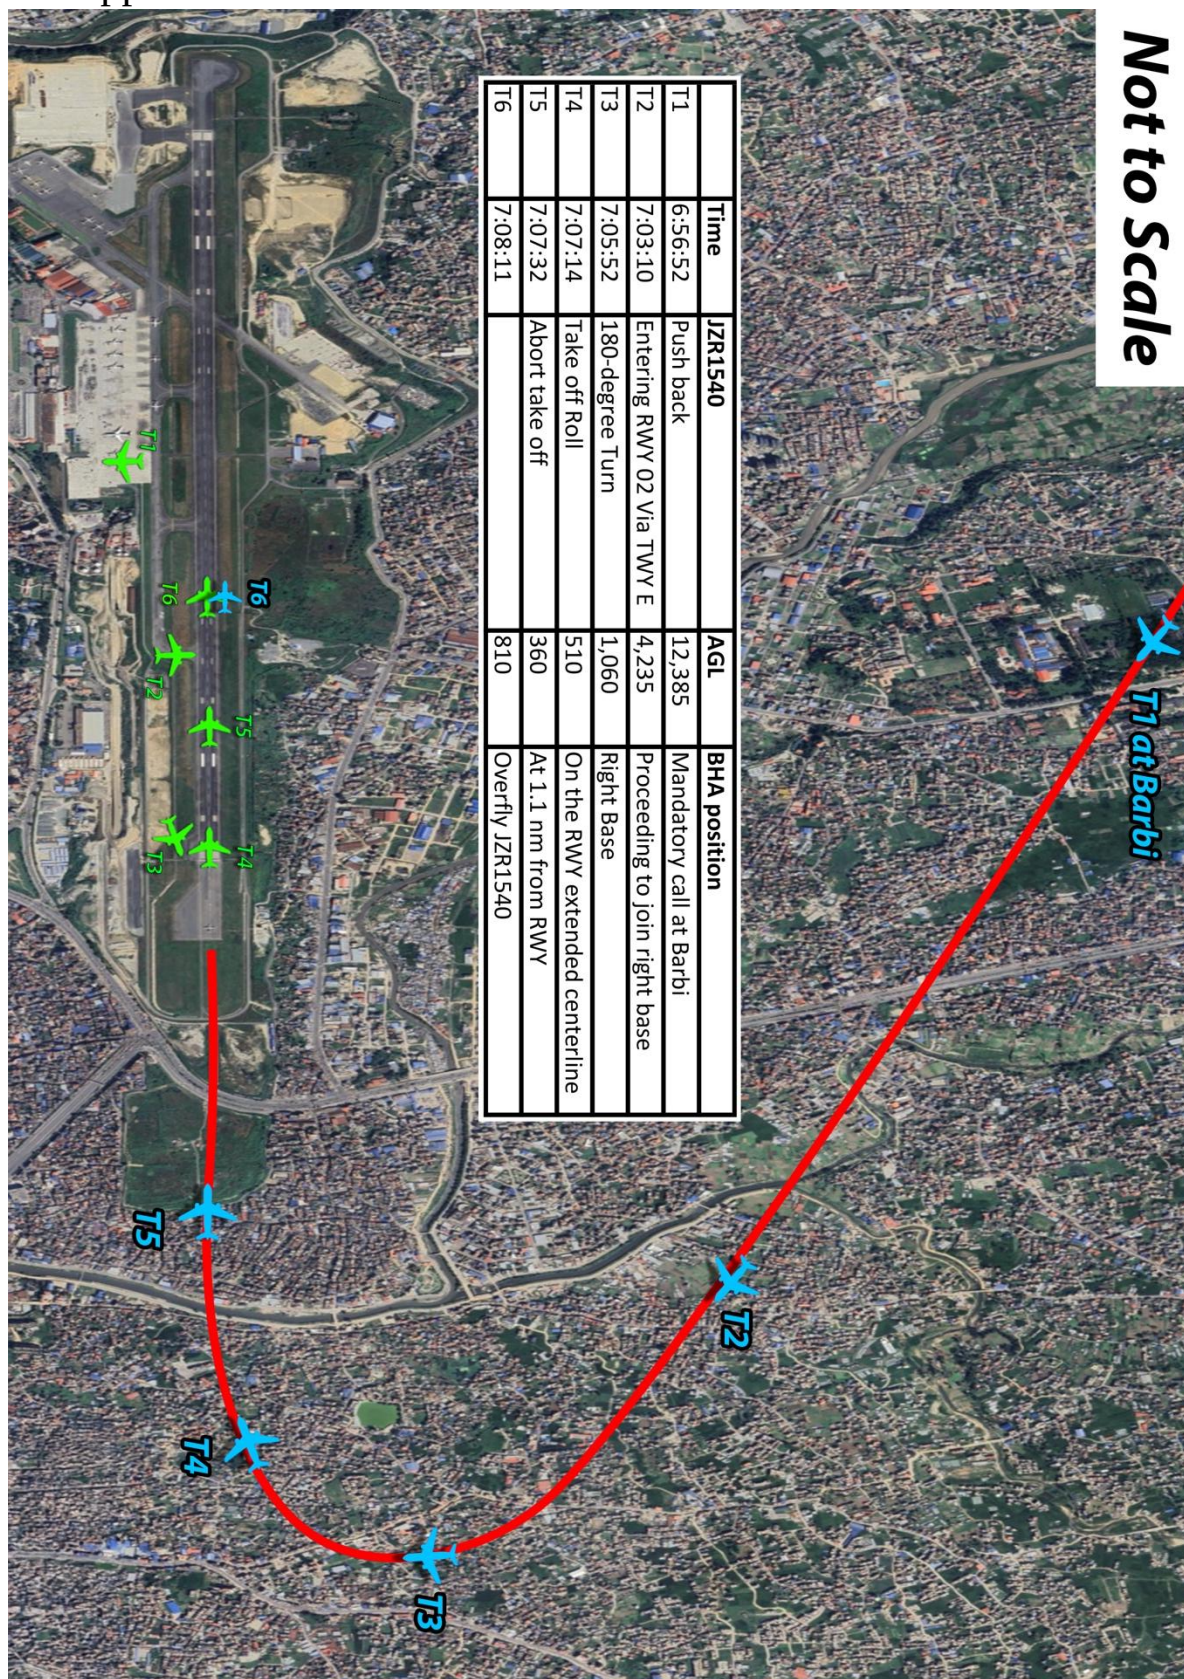
Appendix 2: Position of JZR A320 aircraft and BHA ATR 72

- 2.6 At 07:05:52L, the Captain of JZR 1540 made the 180 degrees reversal turn on the turn pad near the end of runway and at 07:07:14L he increased the engine thrust to commence the take-off roll. According to online ADS-B data, at this time the BHA 100D was on short final to land on RWY 02 and at around 500 ft AGL.

- 2.8 The available online ADS-B data reflected that the aircraft was an ATR72-500 operated by Buddha Air callsign BHA 100D. The ATR72-500 commenced a go-around at around 300 ft AGL and at a distance of around 1.1 nm from the runway.
