AIFN02

Preliminary Report

Flight KU417 Boeing 777/9K-AOD Collision with Stand Structure at Kuwait

7th November 2025 at 0425 Local time

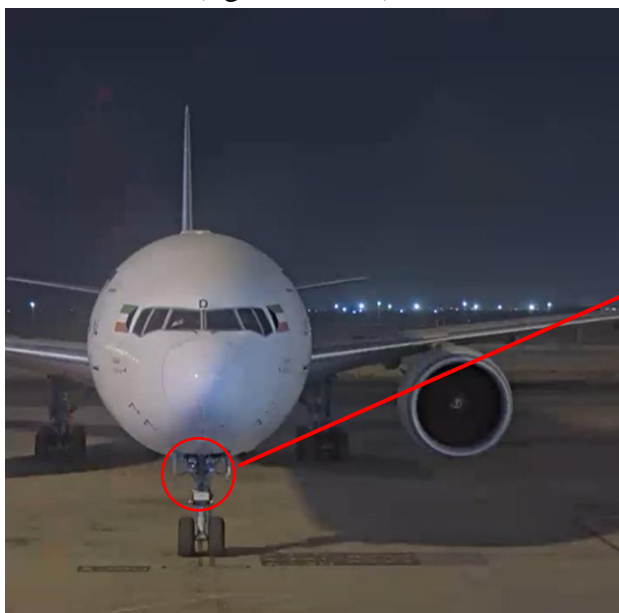
Figure 2: The aircraft after it came to a complete stop

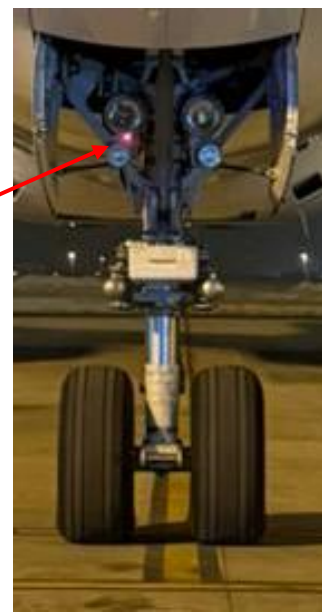
Figure 1: Close up Picture of the nose landing gear showing the red light

which indicate “brake on” but the amber light which indicate “parking brake set” was not illuminated. 30 seconds after the aircraft was stationary, the anti-collision lights turned off which signals the ground crew to approach the aircraft to place the chokes, but from the CCTV cameras only the marshaller was present and people from operation which were not related to the aircraft. The red light “brake set” remained illuminated for 5 minutes before turning off without any ground crew noticing, the light remained off for about 1 minute 15 seconds shown in (figure 3)

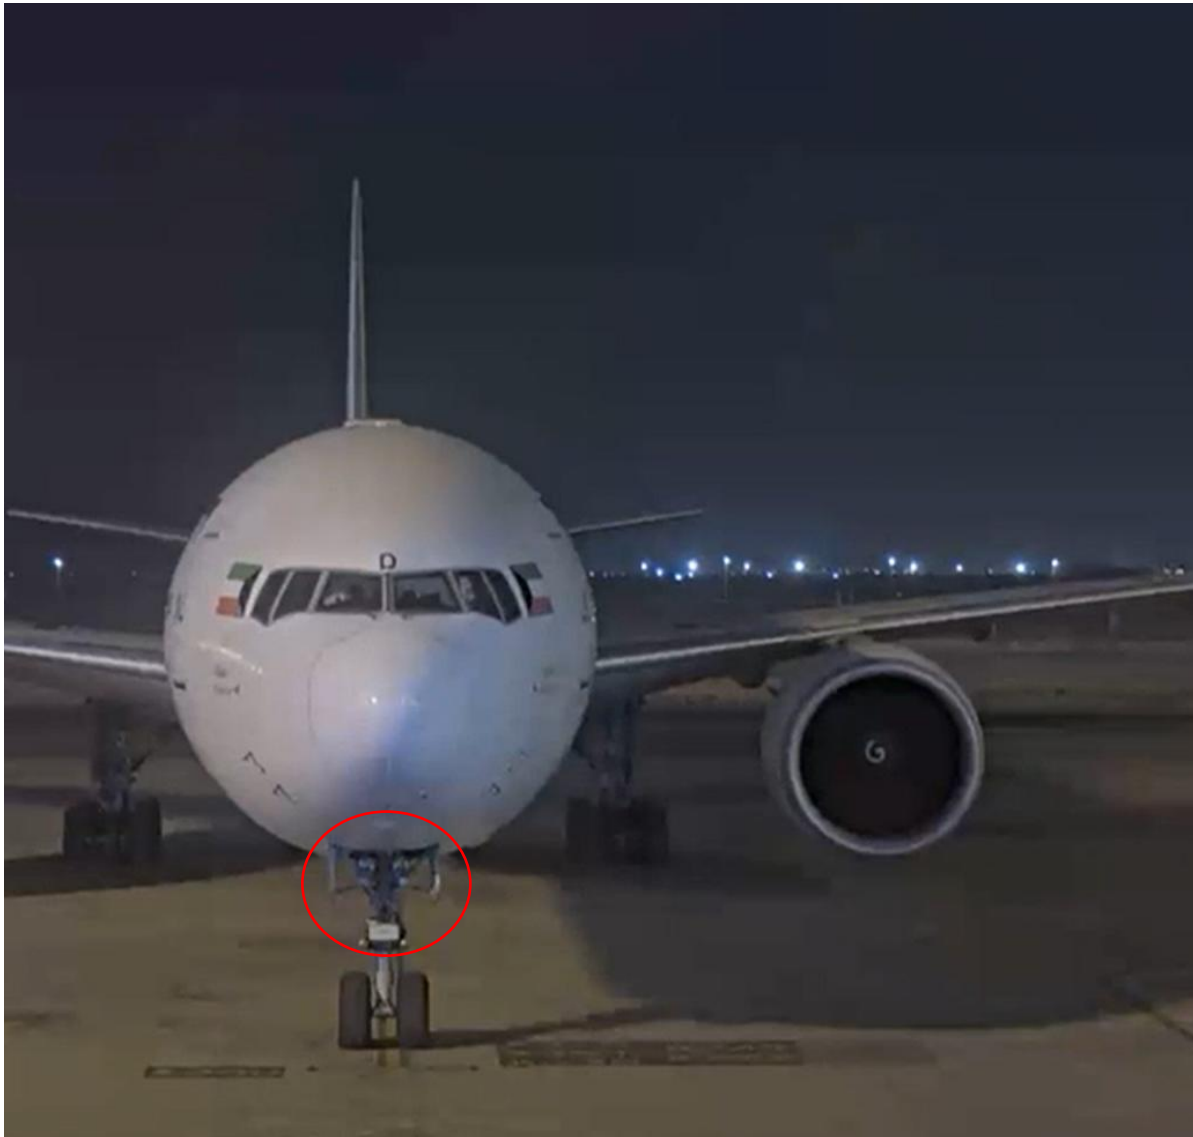
Figure 3: No Lights Visible on The Nose Landing Gear

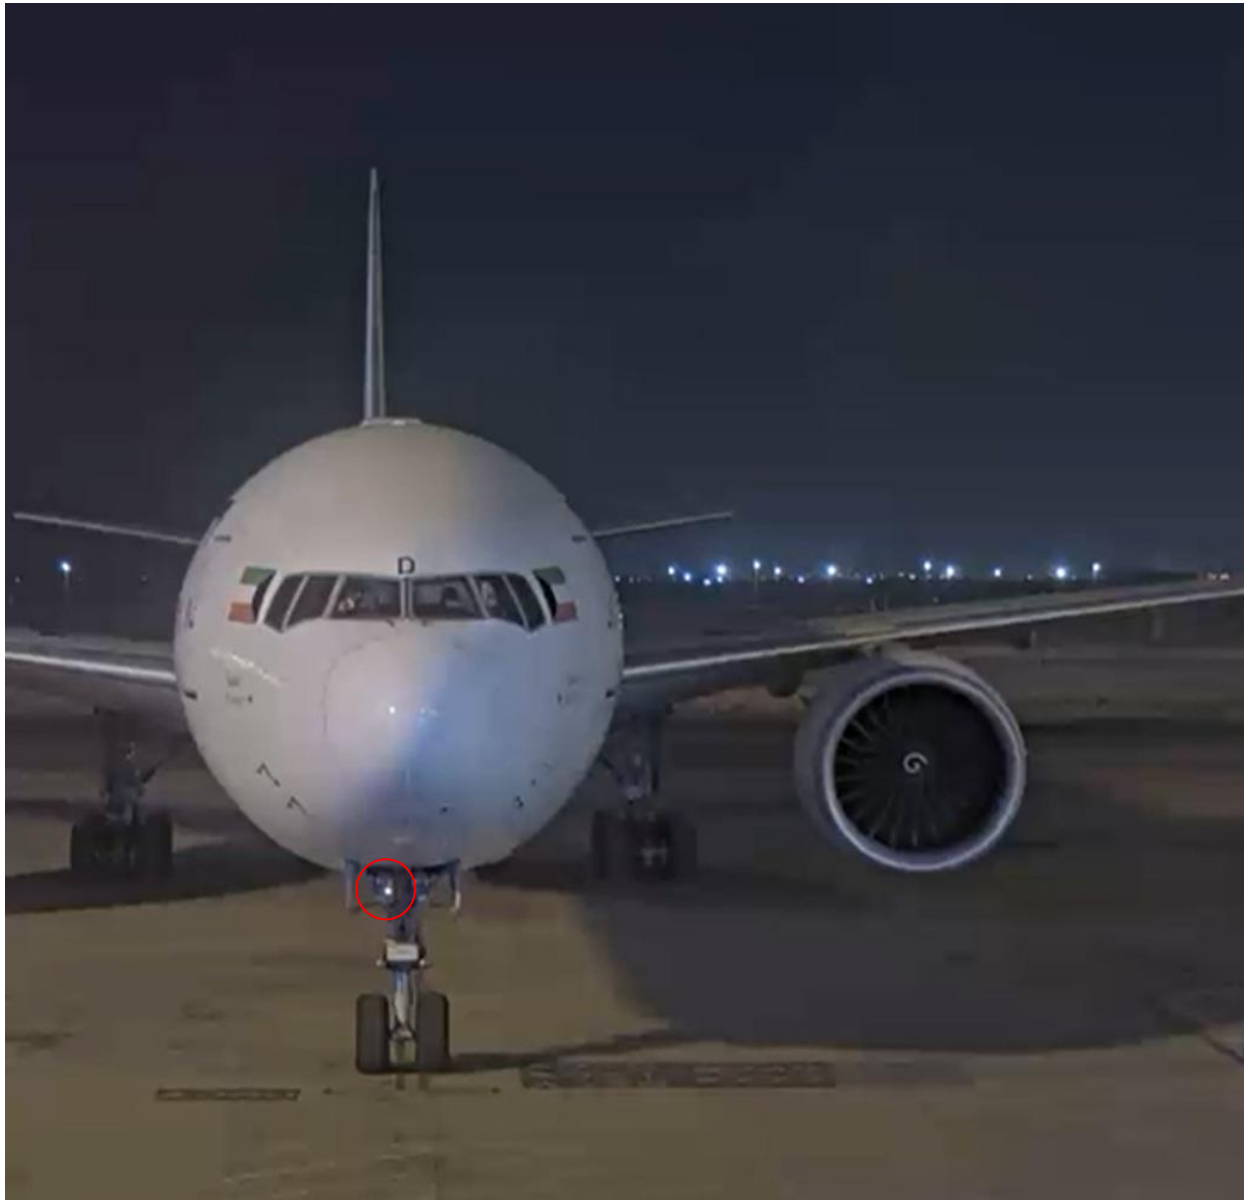
Figure 4: Light Flashing from The Nose Landing Gear

and the aircraft started moving forward slowly due to a slope, the marshaller noticed the moving aircraft and started signaling the pilot to apply the brakes, the pilot signaled that there were no brakes and declared a mayday call on the ground frequency, ground crew member threw chokes on the nose wheel in an attempt to stop the aircraft (figure 5) but it was not effective and the aircraft went over the chokes

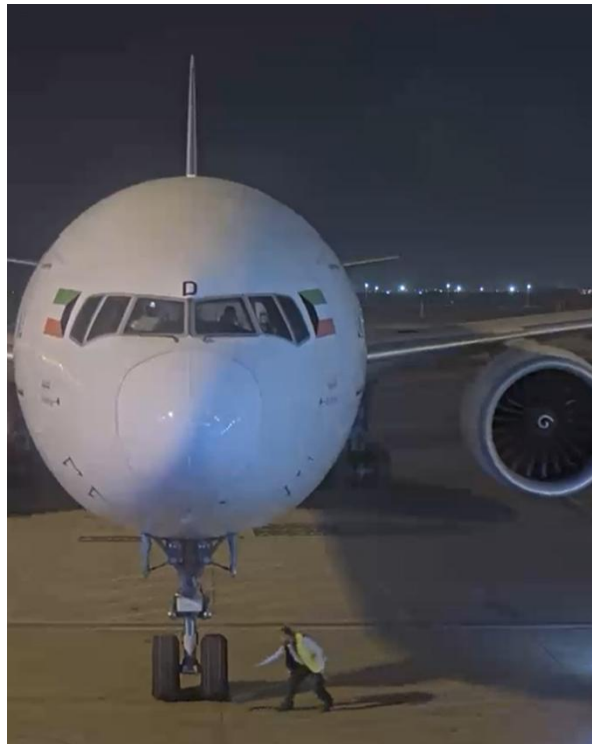
Figure 5: Ground Crew Throwing Chocks

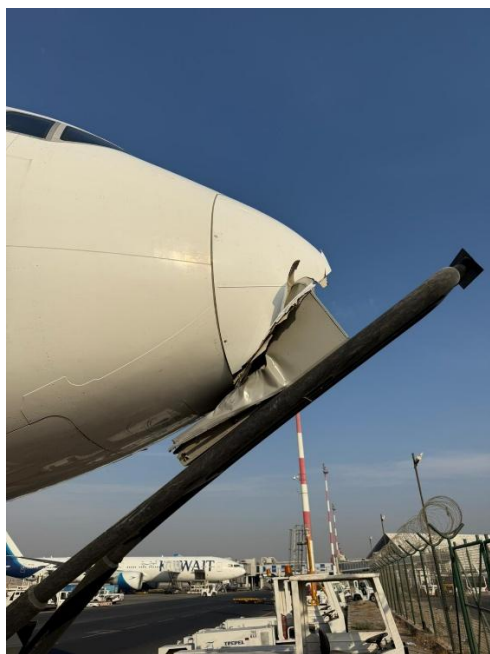
and crossed a service road and the radome struck the stand pole and the landing gear struck the concrete base stopping the aircraft (Figure 6 and 7).

Figure 7: Nose Striking the Stand Pole

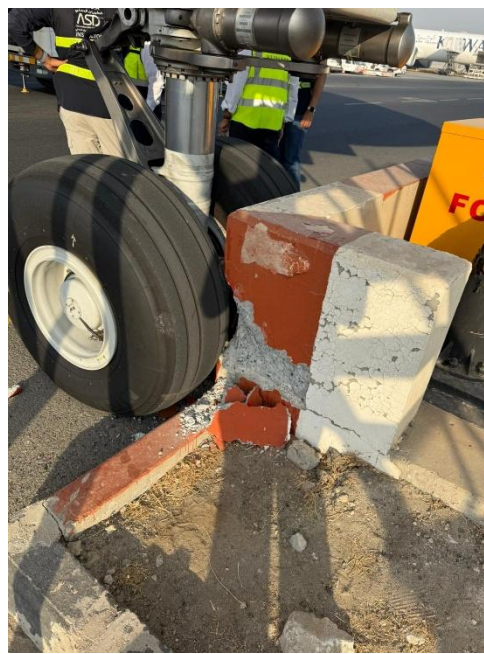
Figure 6: Wheel Hitting the Pole Base

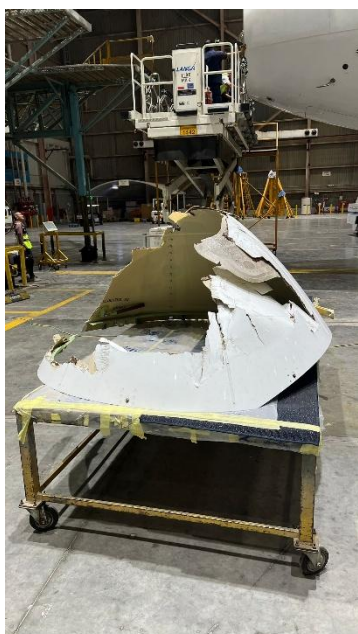
The aircraft was damaged mainly in the radome section (Figure 9) and the underside of the fuselage. The damage of the aircraft is shown as follows:

Figure 9: Radome Damage

In response to the incident, Kuwait Airways enforced all their Boeing 777 fleet to let the electronic hydraulic pumps turned on until the chocks are placed then fully turning the aircraft off.

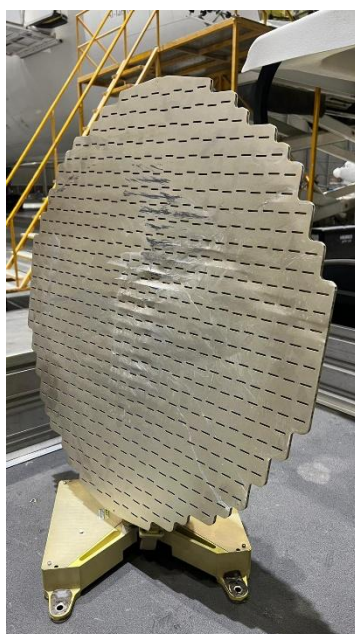
- Radome
 - Weather radar (Figure 10 and 11).
 - Glideslope antenna damaged.
 - Localizer antennas damaged.
 - Radome hinge Arm damaged.
 - Radome hinge assembly arm damaged.
 - Radome link assembly broken.
 - Radome snubber assembly, the plug was found to have chafed at the head.
 - Fuselage Skin, Forward pressure bulkhead on (STA 132.5).

Figure 11: Weather Radar Damage

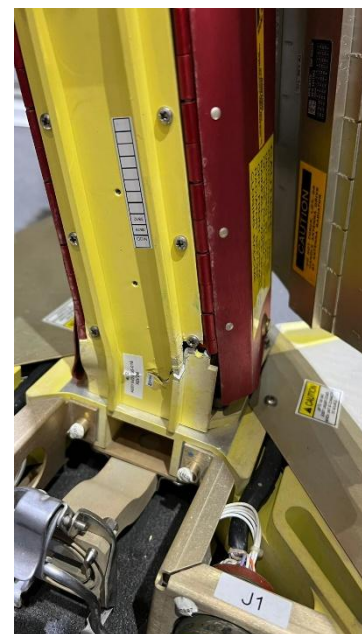
Figure 10: Weather Radar Base Cracked
